Technical Bulletin No. 007

LP® SmartSide® Siding and Trim Explanation of High and Low Point Overlay Fissures

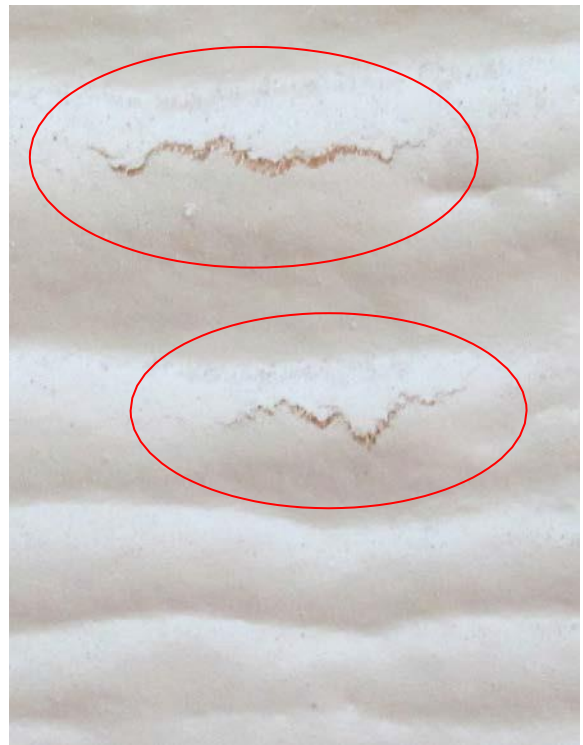
Figure 1

Small surface fissures may be evident in the overlay face and are inherent to the SmartSide production process. Figure one provides an example of a surface fissure. The primed overlay is stretched up to eighteen inches when the texture is pressed into the surface. Small surface fissures will occur at the peaks and valleys of the texture where the texture is highly defined. These very small cracks do not reduce the performance or durability of our siding.

Once the product is finished, these fissures become less evident and are difficult to locate unless someone is intentionally seeking them out. Viewing them from any distance is nearly impossible. The fissures tend to be an amber color and contrast somewhat with the factory primer. When finishing SmartSide siding and trim, white and lighter color paints will require sufficient film thickness to avoid any paint transparency.
