Technical Bulletin No. 007

LP® SmartSide® Siding and Trim Explanation of High and Low Point Overlay Fissures

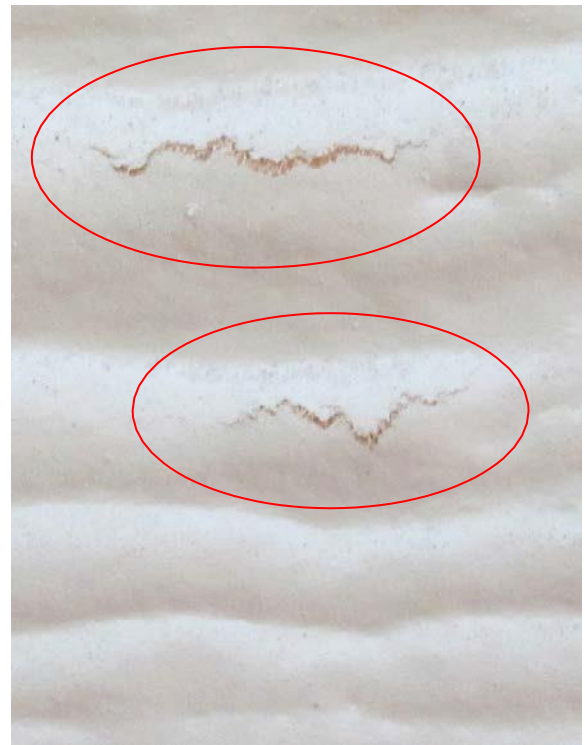
Figure 1

Small surface fissures may be evident in the overlay face and are inherent to the SmartSide production process. Figure one provides an example of a surface fissure. The primed overlay is stretched up to eighteen inches when the texture is pressed into the surface. Small surface fissures will occur at the peaks and valleys of the texture where the texture is highly defined. These very small cracks do not reduce the performance or durability of our siding.

Once the product is finished, these fissures become less evident and are difficult to locate unless someone is intentionally seeking them out. Viewing them from any distance is nearly impossible. The fissures tend to be an amber color and contrast somewhat with the factory primer. When finishing SmartSide siding and trim, white and lighter color paints will require sufficient film thickness to avoid any paint transparency.

SmartSide siding and trim is a line of building materials designed for scrutiny at an architectural scale. Surface fissures have been a part of the SmartSide process products since its commercialization in 1997. The billions of feet sold and the extremely high rate of customer satisfaction demonstrate that the small surface fissures are not a quality defect nor will they impact the durability of the product.
