**Testing of an Exterior Soffit
Assembly in Accordance with SFM
Standard 12-7A-3:
*Under Eave Test***

Soffited Eave Construction: LP[®] FlameBlock[™] Fire-Rated
OSB Sheathing with Cedar Cladding

WFCi Report No. 10085

LP Corporation

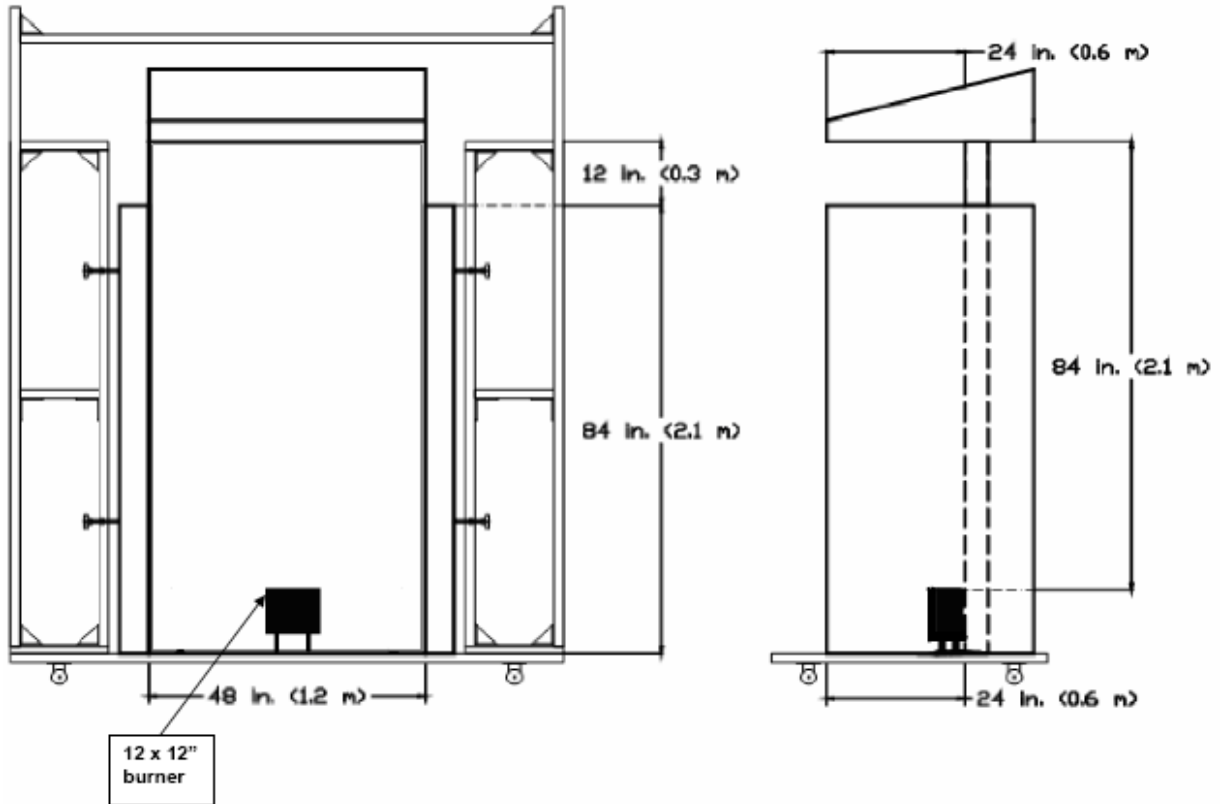
Figure 1. Under Eaves Test Assembly

Testing was performed in accordance with SFM Standard 12-7A-3. The test assembly setup is depicted in Figure 1 below.

1. **Eaves fabrication.** The 4-ft wide x 2-ft. (1.2-m x 0.6 m) test specimen shall be constructed to fit into a 4-ft (1.2 m) wide space at the top of the test fixture described in SFM 12-7A-1. Normal eave framing, joints in soffit material, and other typical features present in the constructed assembly were present in the test specimen.

2. **Test Fixture.** The test fixture shall be as described in SFM 12-7A-1, with the exception that the top soffit projection of the fixture is modified to facilitate installation and removal of eave assemblies. Gypsum board (or equivalent) is used to create a noncombustible wall surface in the 4 x 8 ft. opening in the wall test fixture.

3. **Eaves assembly.** Fit the eave assembly into the test module so that the horizontal surface of the assembly is 84 in. (2.1 m) from the top of the burner.

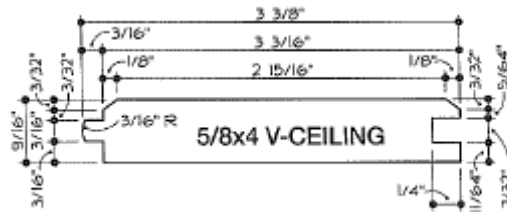
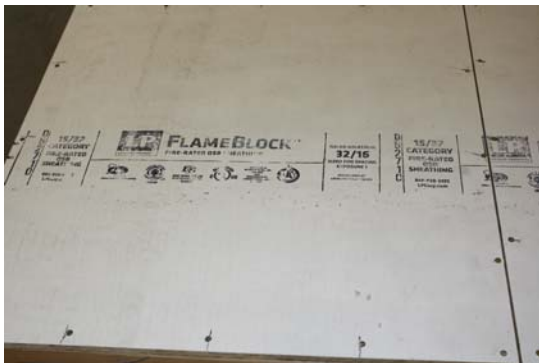
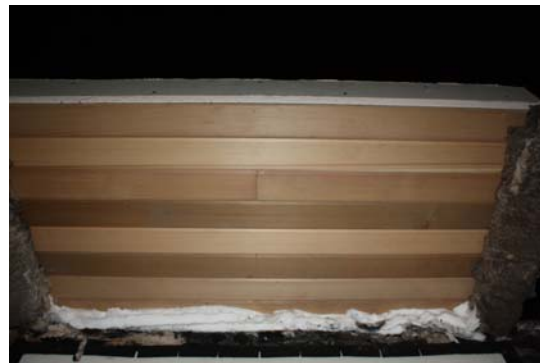
Assembly photographs

The 2' x 4' eave assemblies with FlameBlock base sheathing and clear cedar 5/8x4 v-ceiling T&G soffit cladding were constructed at the WFCi laboratory in the manner shown in the photographs below and Appendix A, and were prepared in accordance with the test method and industry practice.

- **Soffited eave base layer: Labeled LP FlameBlock™ Fire-Rated OSB sheathing, 15/32" minimum nominal thickness (reference ICC ESR-1365)**
 - Pyrotite applied to one face of OSB sheathing [exposed (fire) side]
 - 1/8" gap at joist nailer
- **Soffit Cladding: Cedar 5/8x4 v-ceiling**
 - Blind nailed
 - The 5/8x4 v-ceiling pattern (reference WPA G16 Standard Patterns booklet) represents the narrowest and thinnest dimension solid wood ceiling cladding pattern typically available, and was selected (based on previous test experience) as representative of a potential 'severe case' solid wood cladding application.
