**Testing in Accordance with SFM
Standard 12-7A-1:
*Fire Resistive Standard for
Exterior Wall Siding and Sheathing***

LP[®] FlameBlock[™] Fire-Rated OSB Sheathing (7/16" Minimum
Nominal Thickness) with Various Claddings:

**PN# 10023
Report No. 10023.1**

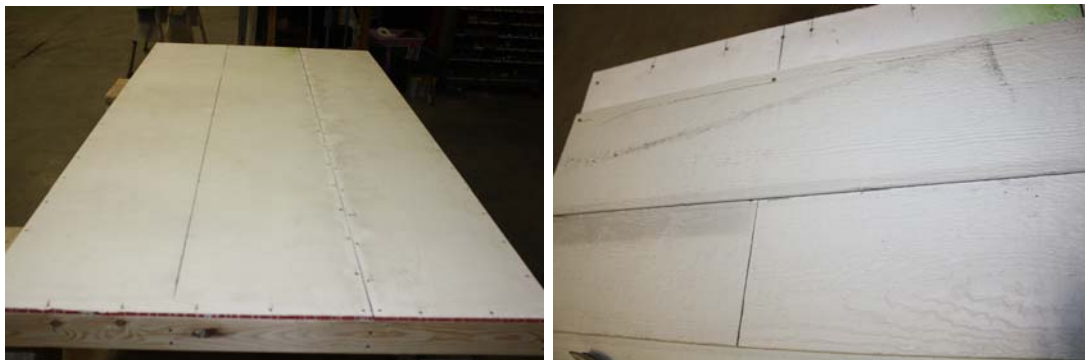
Test Series No. 1: Construction Photographs – Lap Siding (note butt joints every other course)

- **Sheathing: LP FlameBlock™ 4'x8' Fire-Rated OSB sheathing, 7/16" minimum nominal thickness (reference ICC ESR-1365)**
 - Minimum Pyrotite thickness of 0.06" applied to fiberglass mat
 - Pyrotite laminate applied to one face of OSB sheathing [exposed (fire) side]
- **Cladding: SmartSide™ Precision Series Lap siding (limited to strand substrate)**

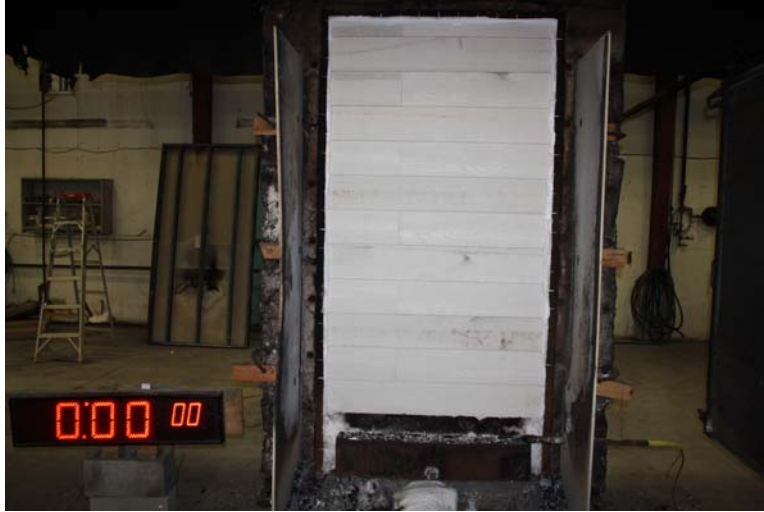
Test Series No. 1: Completed test assembly – Lap Siding

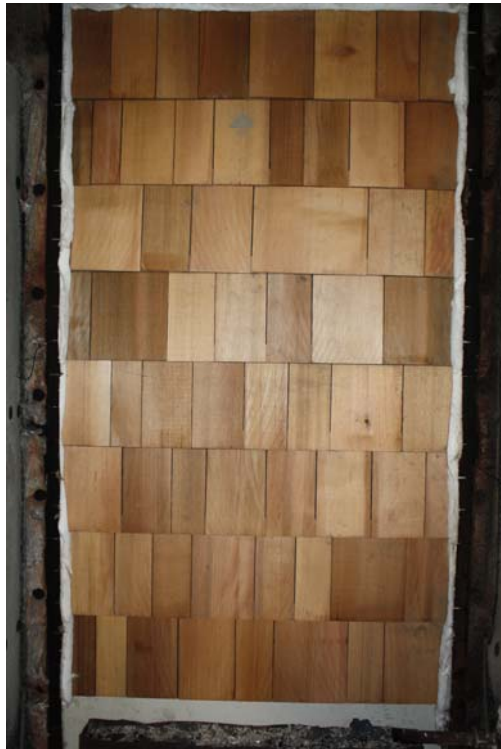
Test Series No. 2: Completed Wall Assembly

- **Sheathing: LP FlameBlock™ Fire-Rated OSB sheathing, 7/16" minimum nominal thickness (reference ICC ESR-1365)**
 - Minimum Pyrotite thickness of 0.06" applied by direct process to OSB sheathing
 - Pyrotite applied to one face of OSB sheathing [exposed (fire) side]
- **Cladding: Cedar Sidewall Shingles, 1/2" butt end thickness (installed in accordance with industry standard/manufacturer's instructions)**

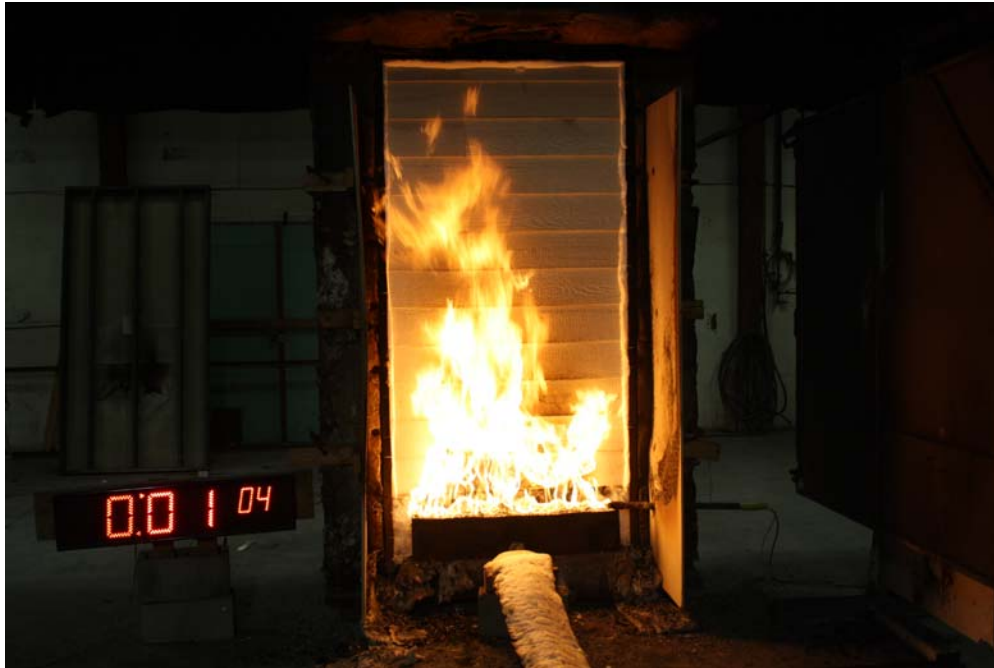
Test time = 1 minute

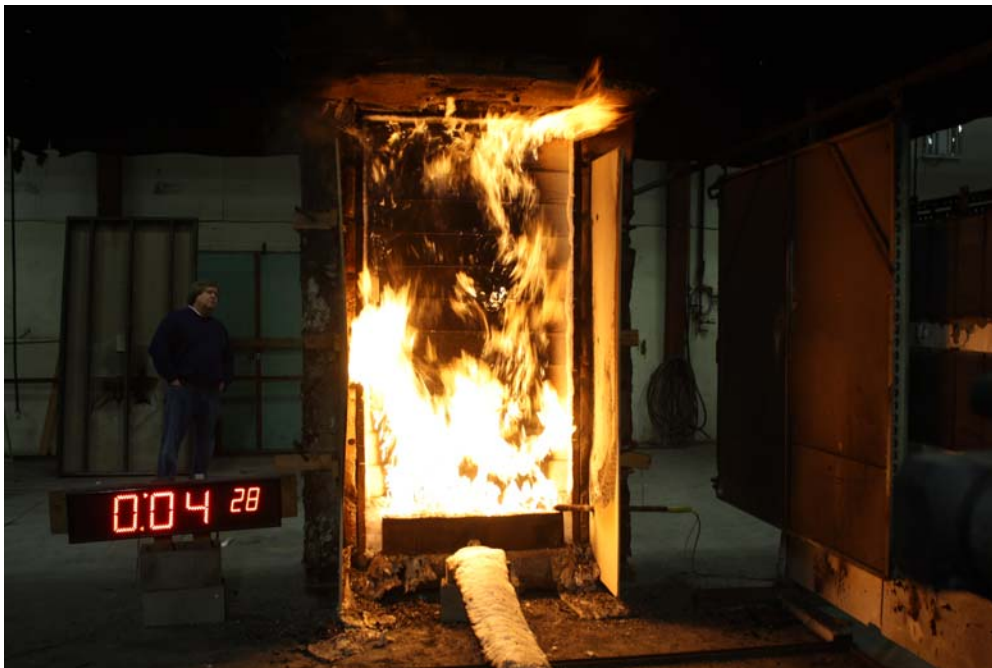
Midway through burner exposure

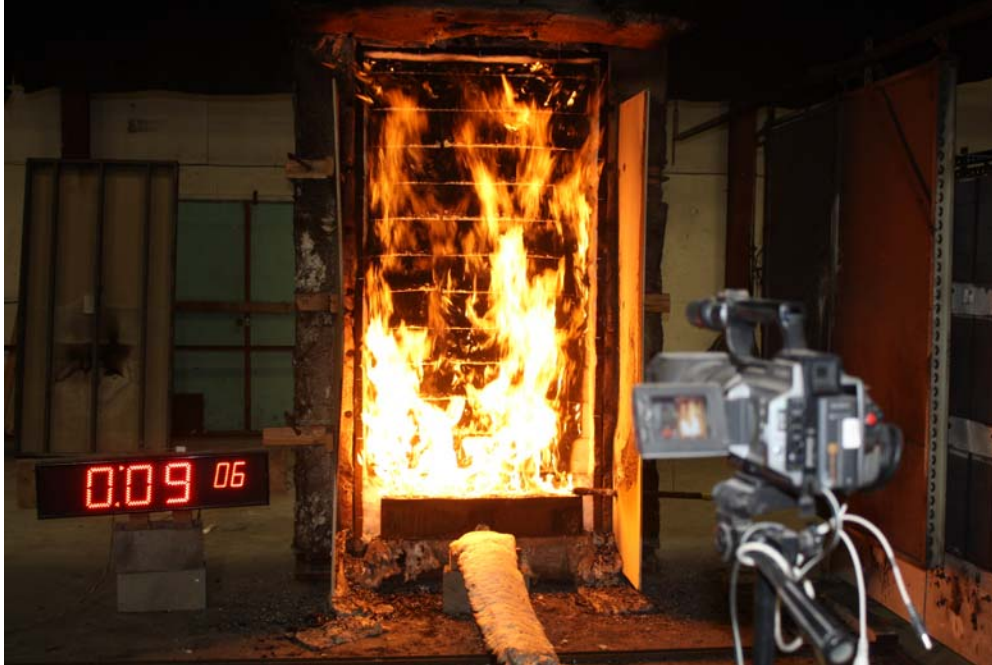
Prior to burner termination

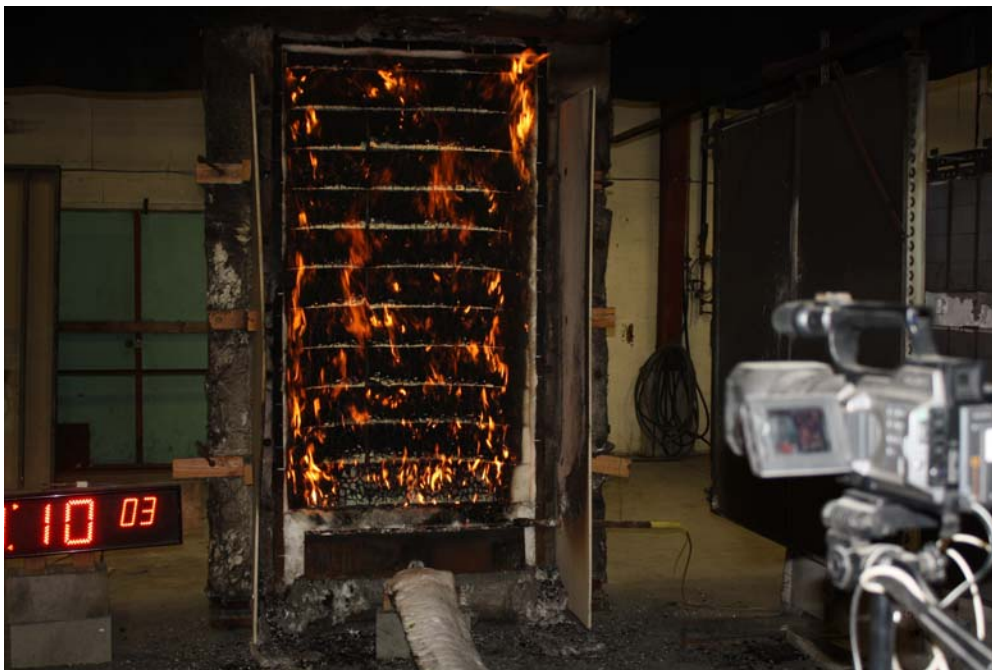
Immediately after termination of burner

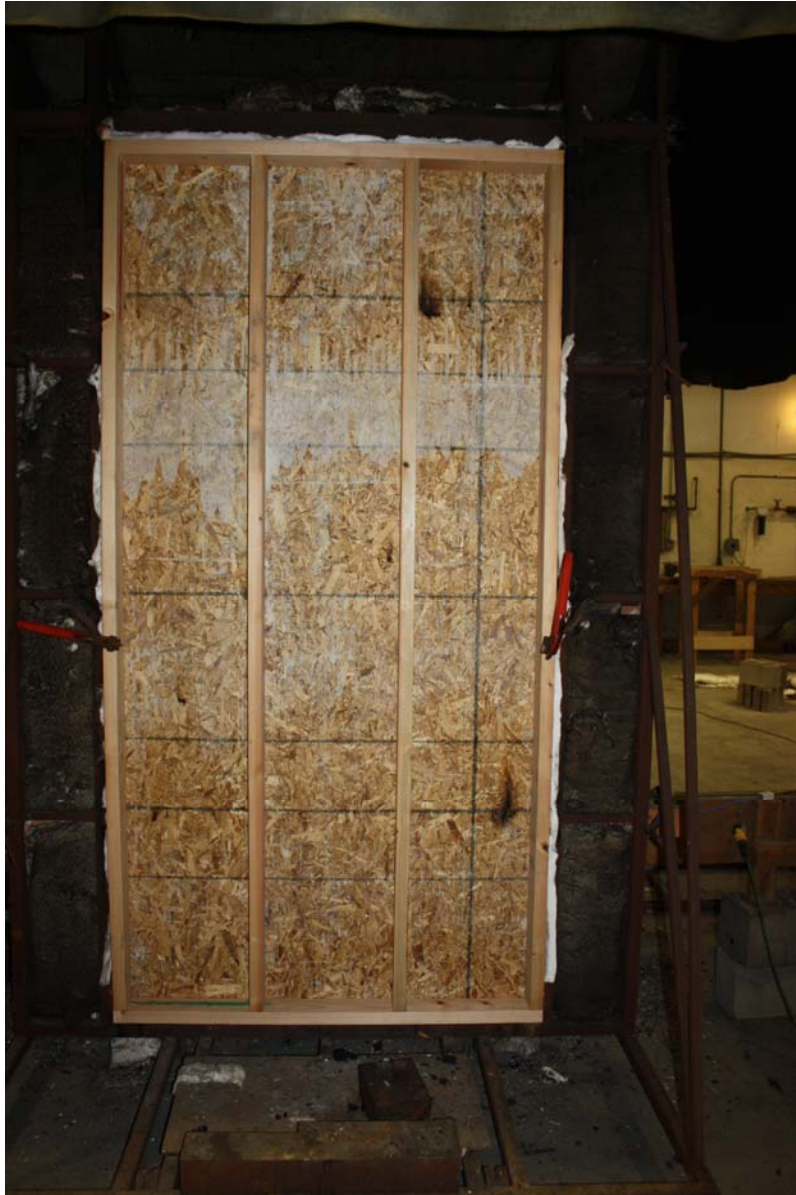
Unexposed side at test termination

Trial	Result	Notes
A (Test 5)	Pass- no signs of flame-through or glow on unexposed side	Cladding ignited at 50 s with vigorous flaming, flames out at 16 min, glowing combustion at various locations on sample surface until test terminated at 70 minutes - IR imaging shows diminishing temps on unexposed side at test termination
B (Test 7)	Pass- no signs of flame-through or glow on unexposed side	Cladding ignited at 45 s with vigorous flaming, all flame out prior to 20 min, glowing combustion at various locations on sample surface until test terminated at 70 minutes - IR imaging shows diminishing temps on unexposed side at test termination
C (Test 8)	Pass- no signs of flame-through or glow on unexposed side	Cladding ignited at 49 s with vigorous flaming, glowing combustion at various locations on sample surface until test terminated at 70 minutes - IR imaging shows diminishing temps on unexposed side at test termination

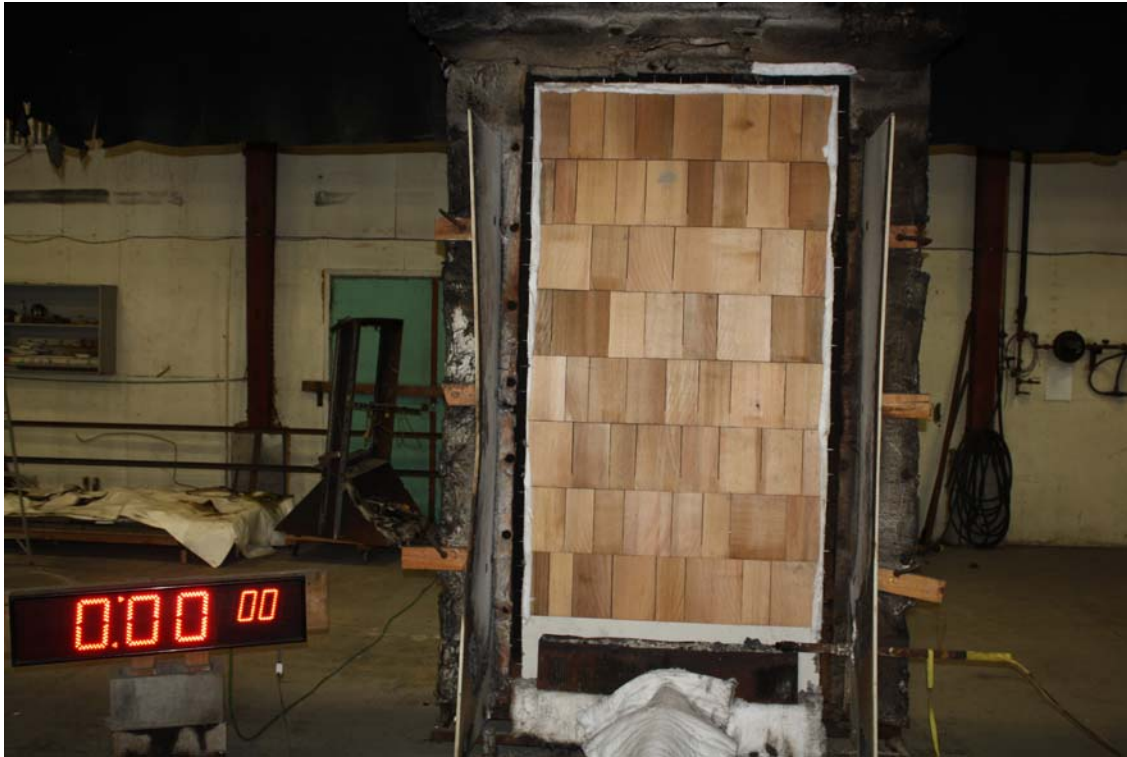
Prior to test

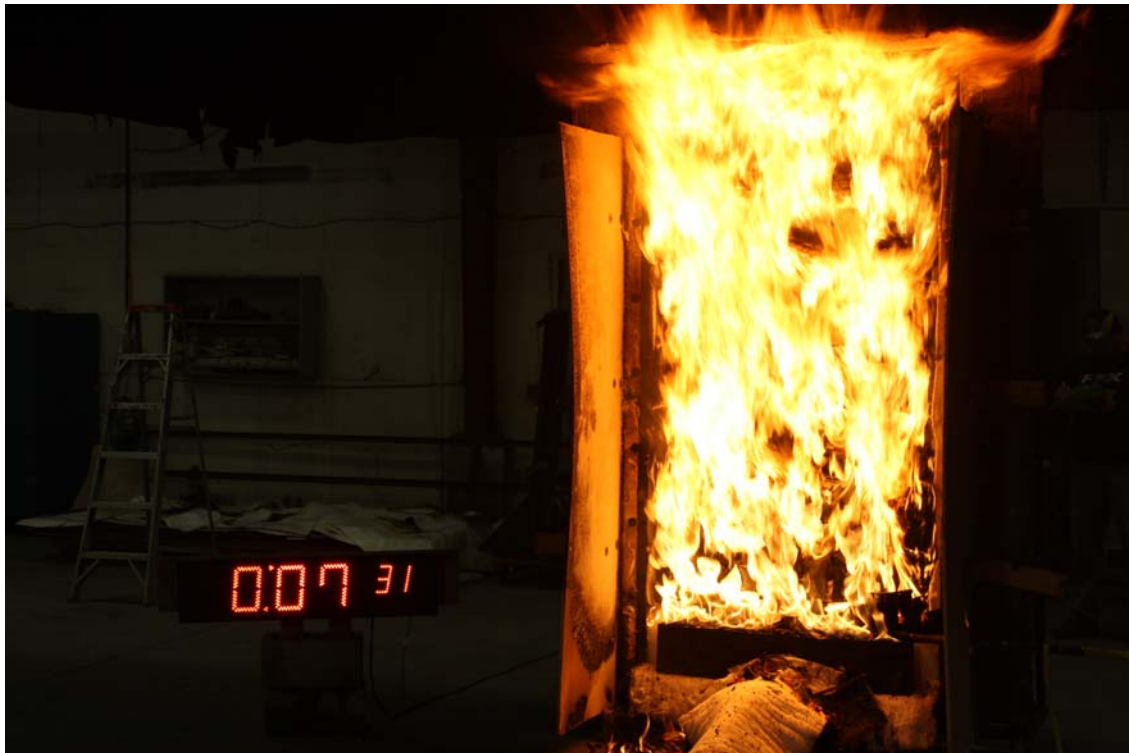
T = 7.5 minutes

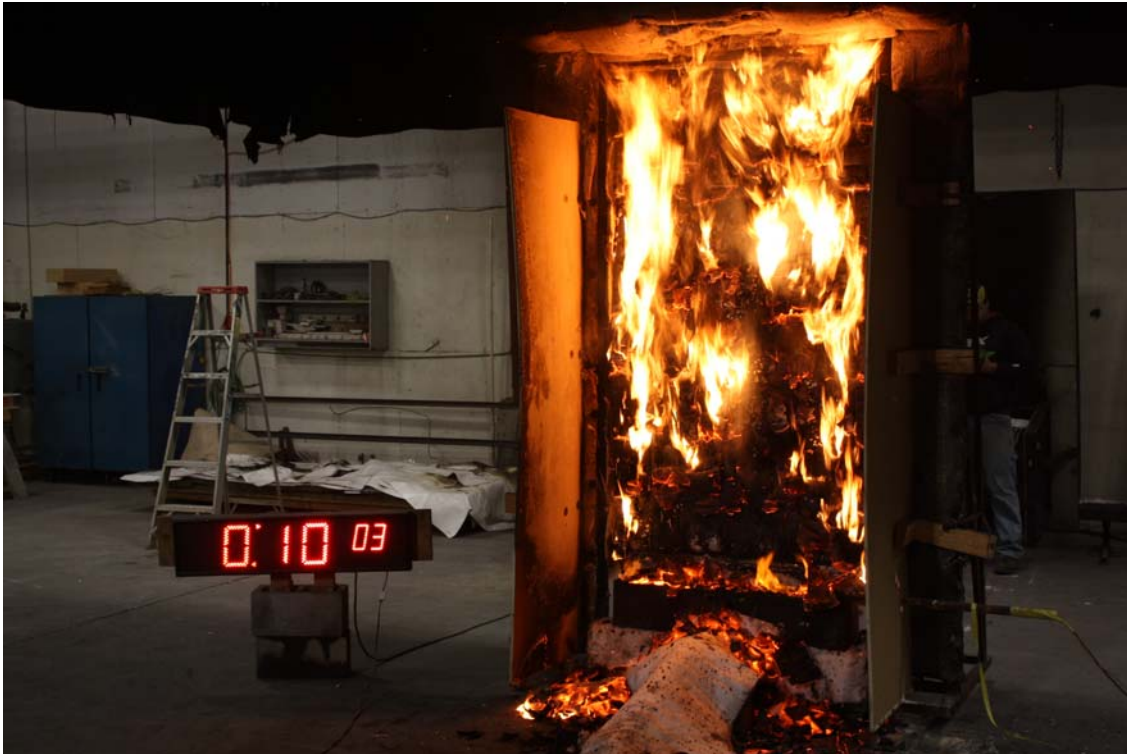
Termination of burner exposure

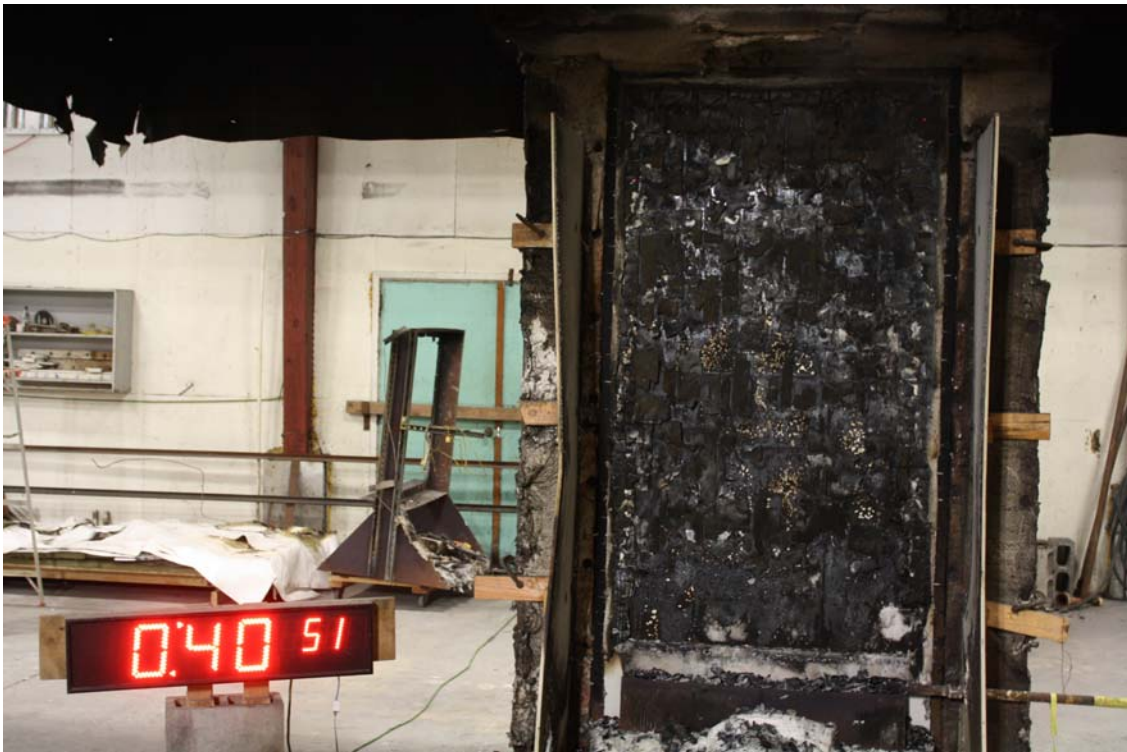
Exposed face at T = 41 minutes

Trial	Result	Notes
A (Test 10)	Pass- no signs of flame-through or glow on unexposed side	Shingles ignited at 28 s with vigorous flaming, flames out at 23 min, glowing combustion at various locations on sample surface until test terminated at 70 minutes - IR imaging shows diminishing temps on unexposed side at test termination
B (Test 11)	Pass- no signs of flame-through or glow on unexposed side	Cladding ignited at 28 s with vigorous flaming, all flame out at 27 min, glowing combustion at various locations on sample surface until test terminated at 70 minutes - IR imaging shows diminishing temps on unexposed side at test termination
C (Test 12)	Pass- no signs of flame-through or glow on unexposed side	Cladding ignited at 23 s with vigorous flaming, glowing combustion at various locations on sample surface until test terminated at 70 minutes - IR imaging shows diminishing temps on unexposed side at test termination

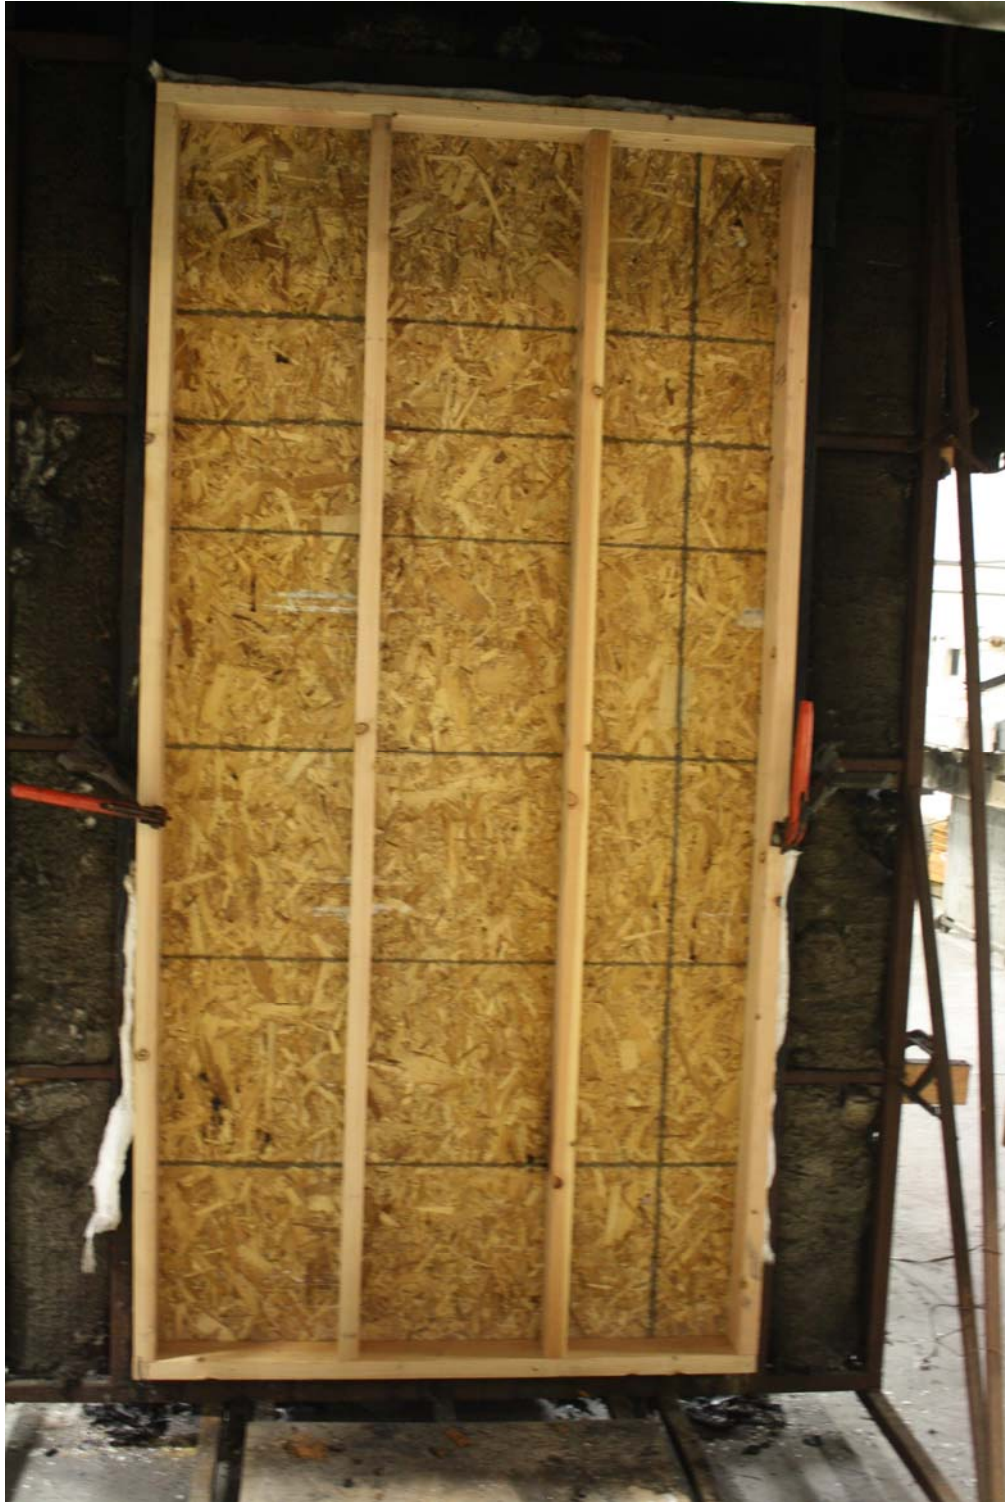
Unexposed face at test termination
